# Seismic vulnerability assessment of historical masonry structural systems

P.G. Asteris<sup>a,\*</sup>, M.P. Chronopoulos<sup>b</sup>, C.Z. Chrysostomou<sup>c</sup>, H. Varum<sup>d</sup>, V. Plevris<sup>a</sup>, N. Kyriakides<sup>c</sup>, V. Silva<sup>d</sup>

Masonry structures are complex systems that require a thorough and detailed knowledge and information regarding their behavior under seismic loading. Appropriate modeling of a masonry structure is a prerequisite for a reliable earthquake resistant design or assessment. However, modeling a real structure to a robust quantitative (mathematical) representation is a very difficult, complex and computationally demanding task. This paper presents a methodology for earthquake resistant design or assessment of masonry structural systems. The entire process is illustrated using case studies from historical masonry structures in the European area. In particular, the applicability of the proposed method is checked via analyses of existing masonry buildings in three countries, namely Greece, Portugal and Cyprus, with different seismicity levels, influencing the risk impacting the masonry structures. Useful conclusions are drawn regardi

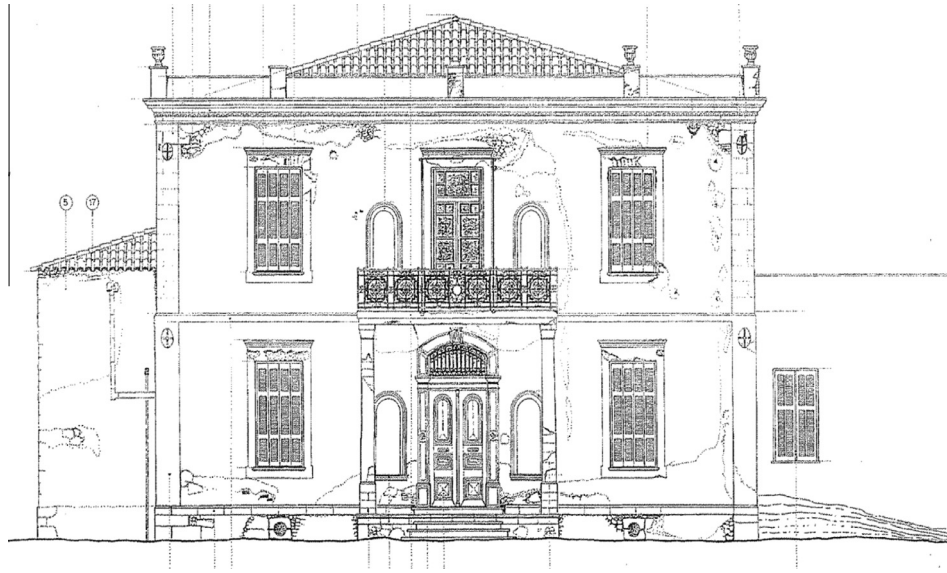
Fig. 4. South facade of the building.

the four corners of the building. The ties, until today, and despite the corrosion and the subsequent decay, offered a certain degree of consolidation. The floors and roof are wooden structures. The roof is hipped, based on the perimeter bearing walls of the building. Moreover, two additional buildings are attached laterally to the main one, as shown in Fig. 4.

The main building has dimensions of  $15.2 \times 15.85 \text{ m}^2$ , the west building  $2.65 \times 5.05 \text{ m}^2$  and the east  $5.65 \times 7.00 \text{ m}^2$ . The height of the main building is 10.87 m and the maximum height including the roof is equal to 13.30 m. The ground floor shows almost completely symmetry with a wide main hallway that divides the building into two symmetrical wings. As regards the morphological description, complete symmetry is observed in the facades, which are characterized by elaborated ornamentation. Most architectural and decorative elements are concentrated on the front facade whereas the rest are distinguished by simplicity.
